# Grounding and Bonding in Communications Systems

David Brender

Copper Development Association Inc.

Miramar, March 8, 2013

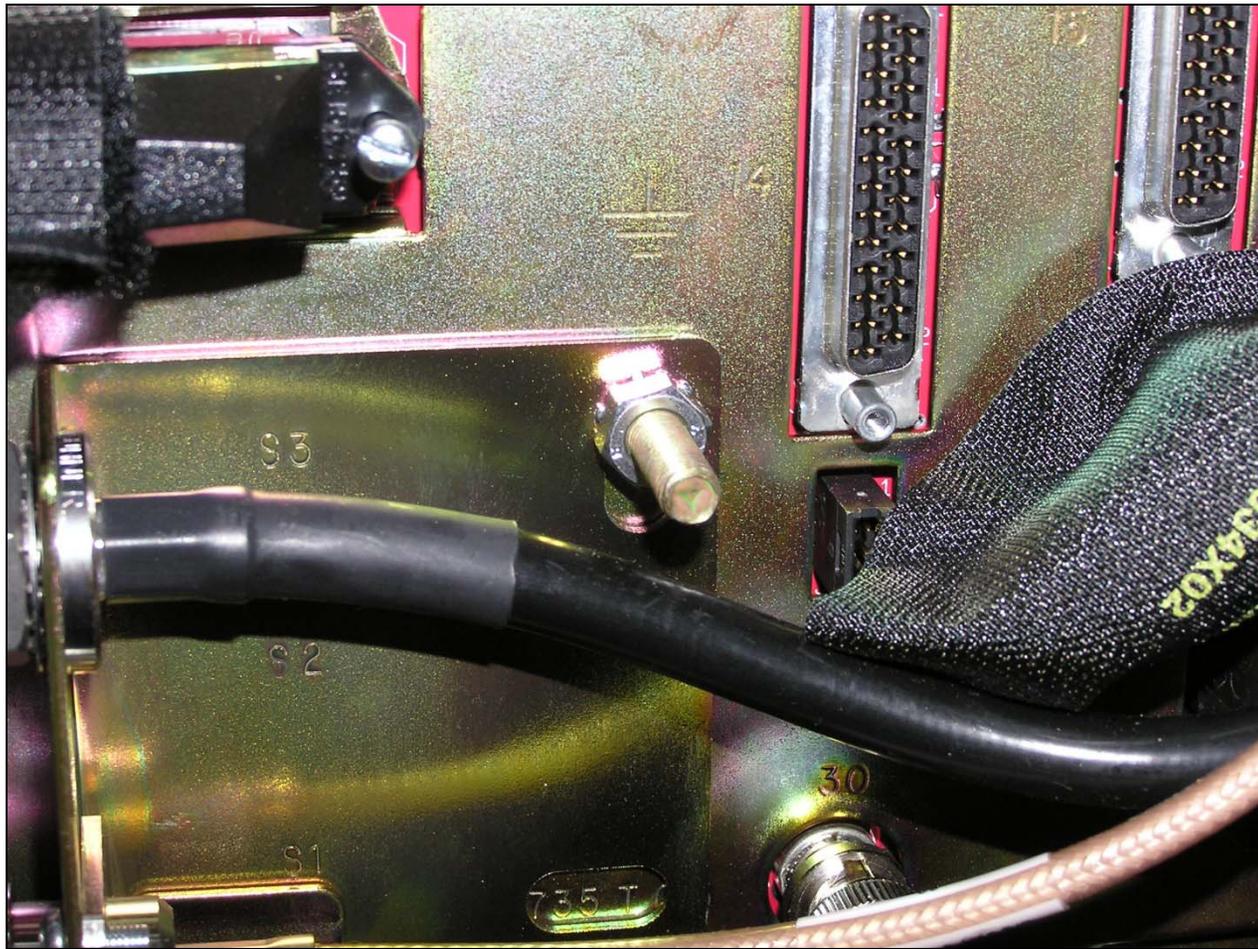
# Throughout The System

## Ungrounded equipment cabinets

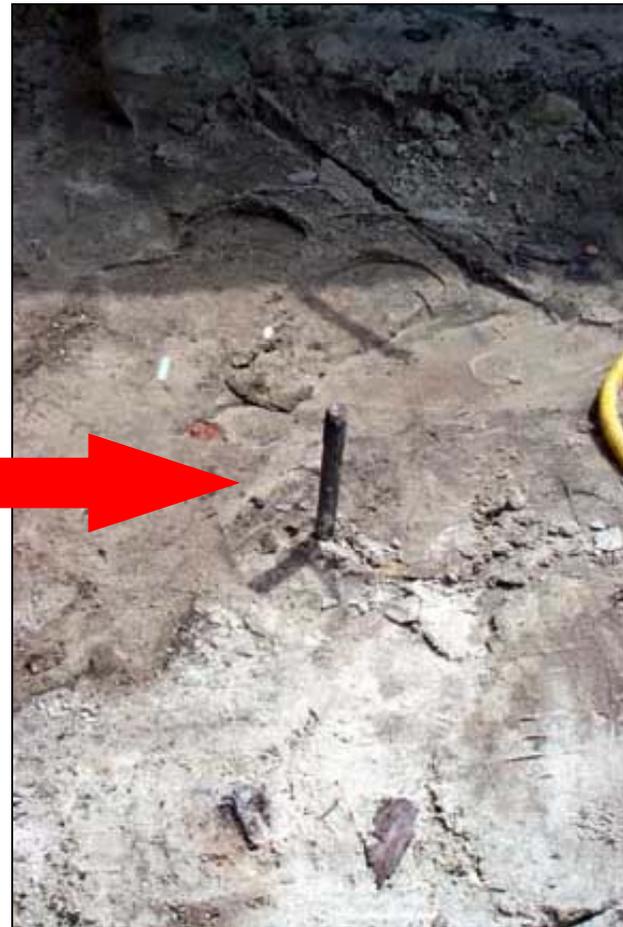
# Facility ground at Apopka

**Main electrode was all-thread rod**

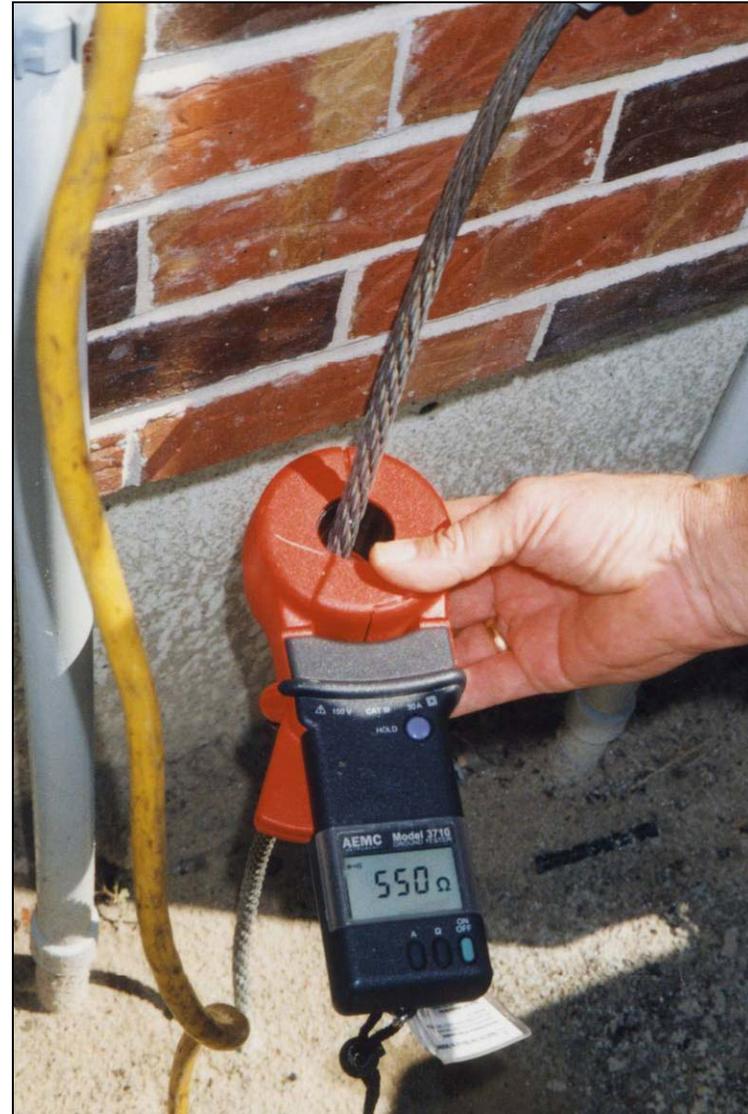
# Old Apopka ground rod

**Measured 550 ohms**

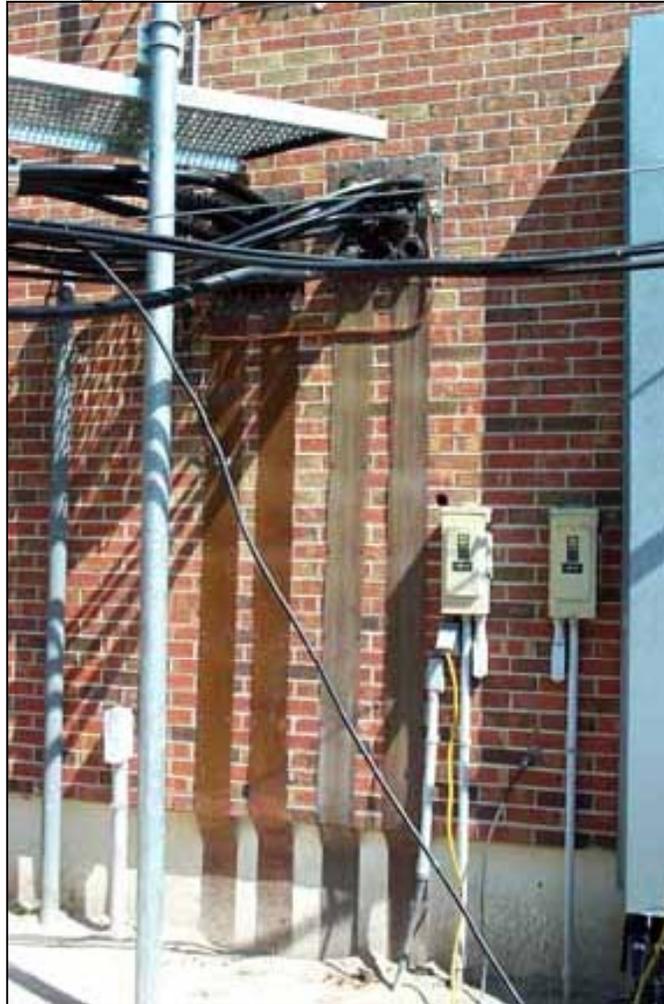
# Outside Firewall

**Only ONE Cu strip connected to electrode**

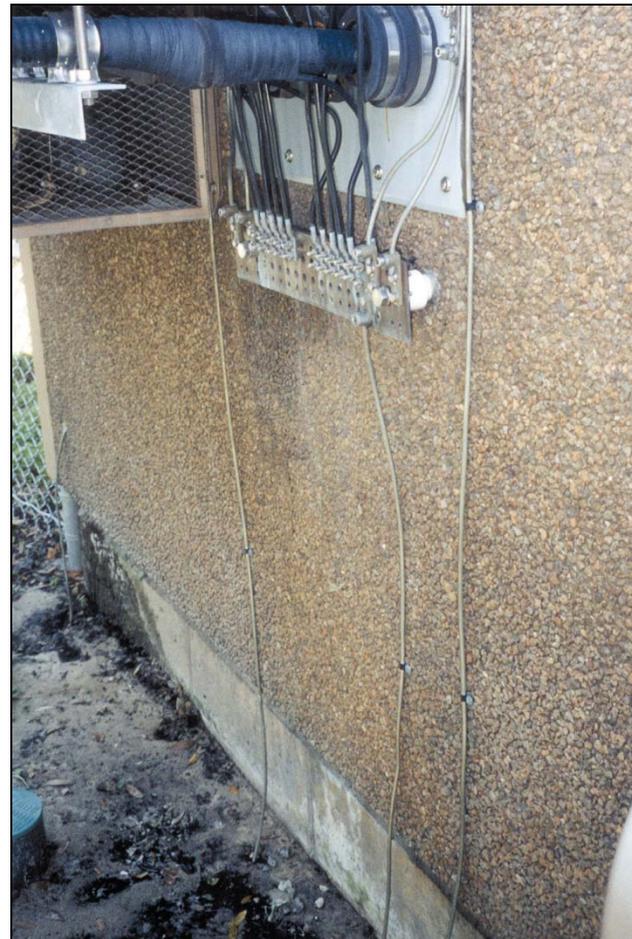
# Cellular side of site

- Original coax ground on
- horizontal run
- #2 Cu. conductor

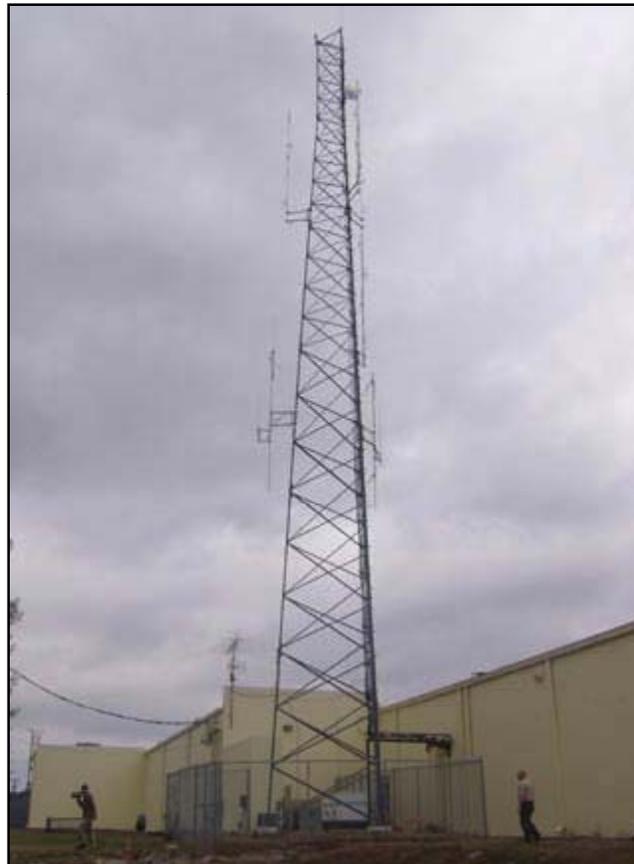
Tower had separate grounding

**121 foot tower erected in 2007**

**Separate ground independent from building**

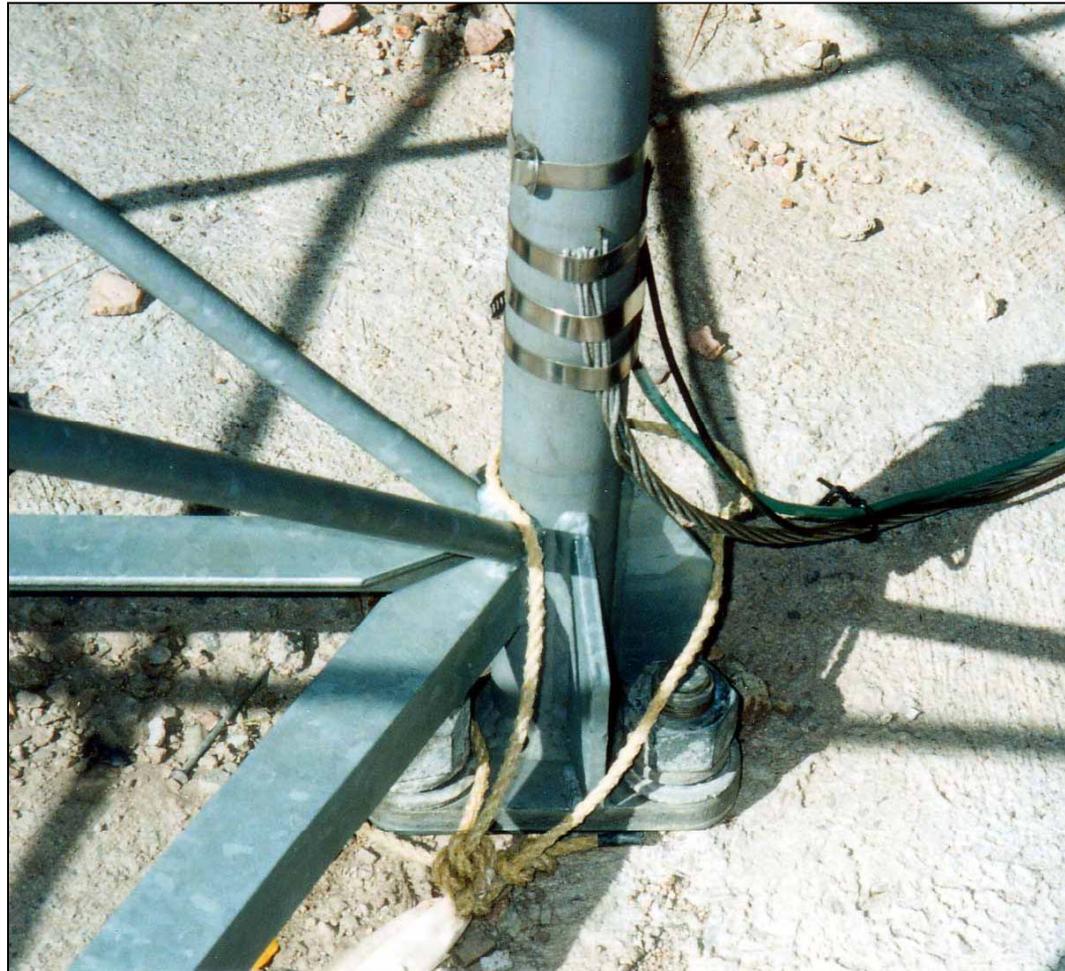
# Actual tower grounding

## Proper connection methods?

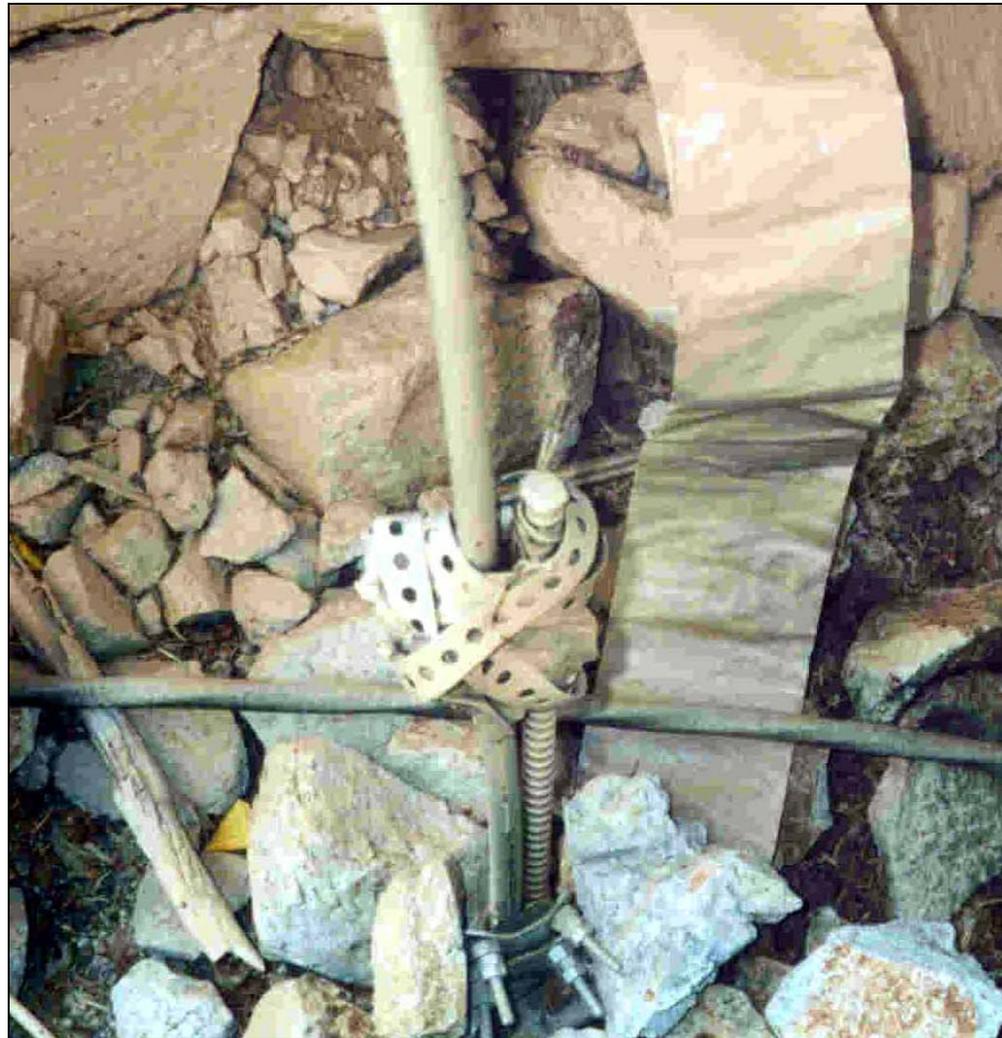
# Actual connection to ground rod

## Proper connection methods?

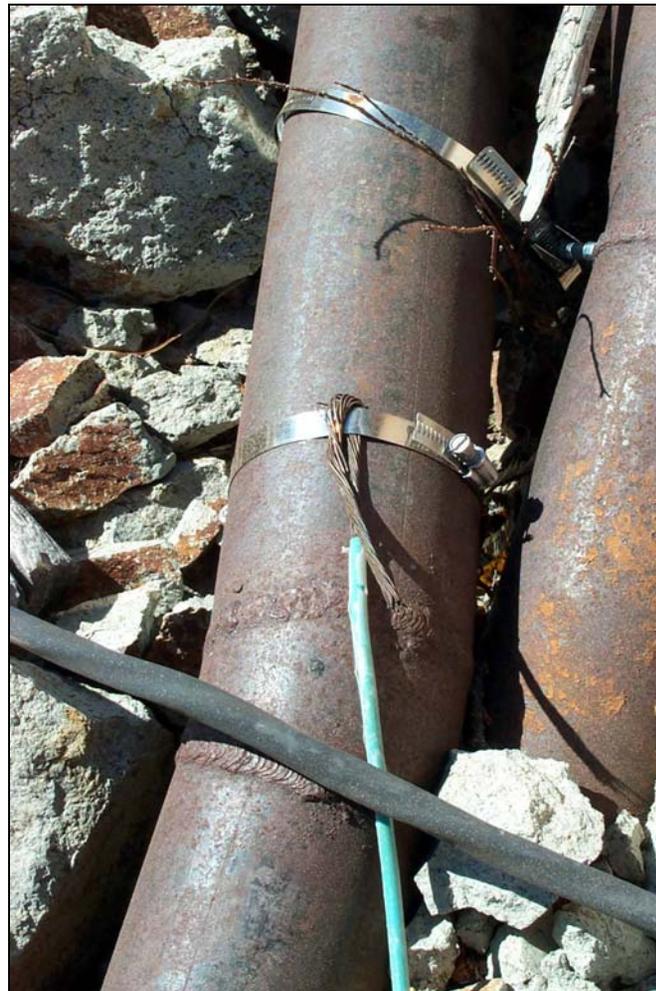
# Actual water pipe bonding

## Corrosion and connection errors.

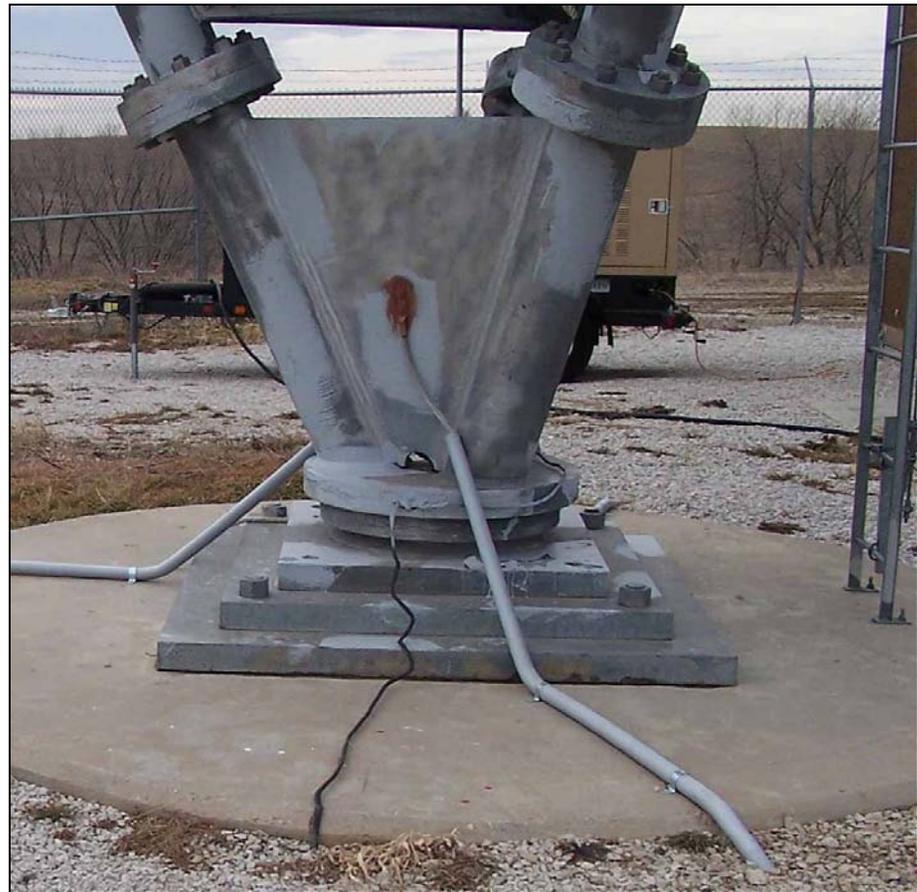
At tower base

**2- 8 ft. ground rods**

**190  $\Omega$**

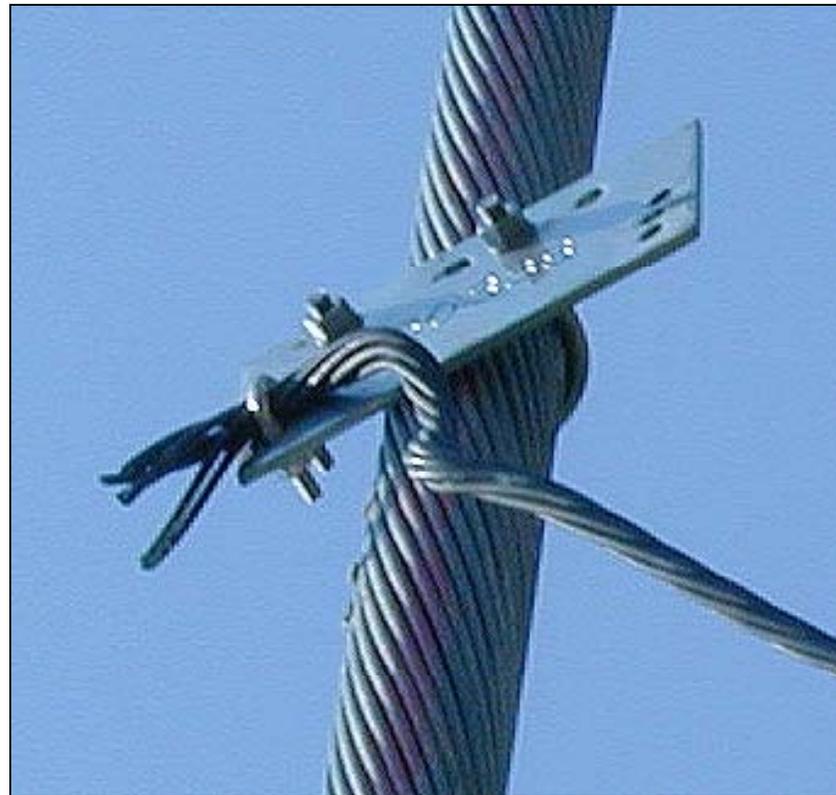
# Guy wires

**Note double U-bolts**

**Connectors not listed**

**90° angles**

**Vibration**

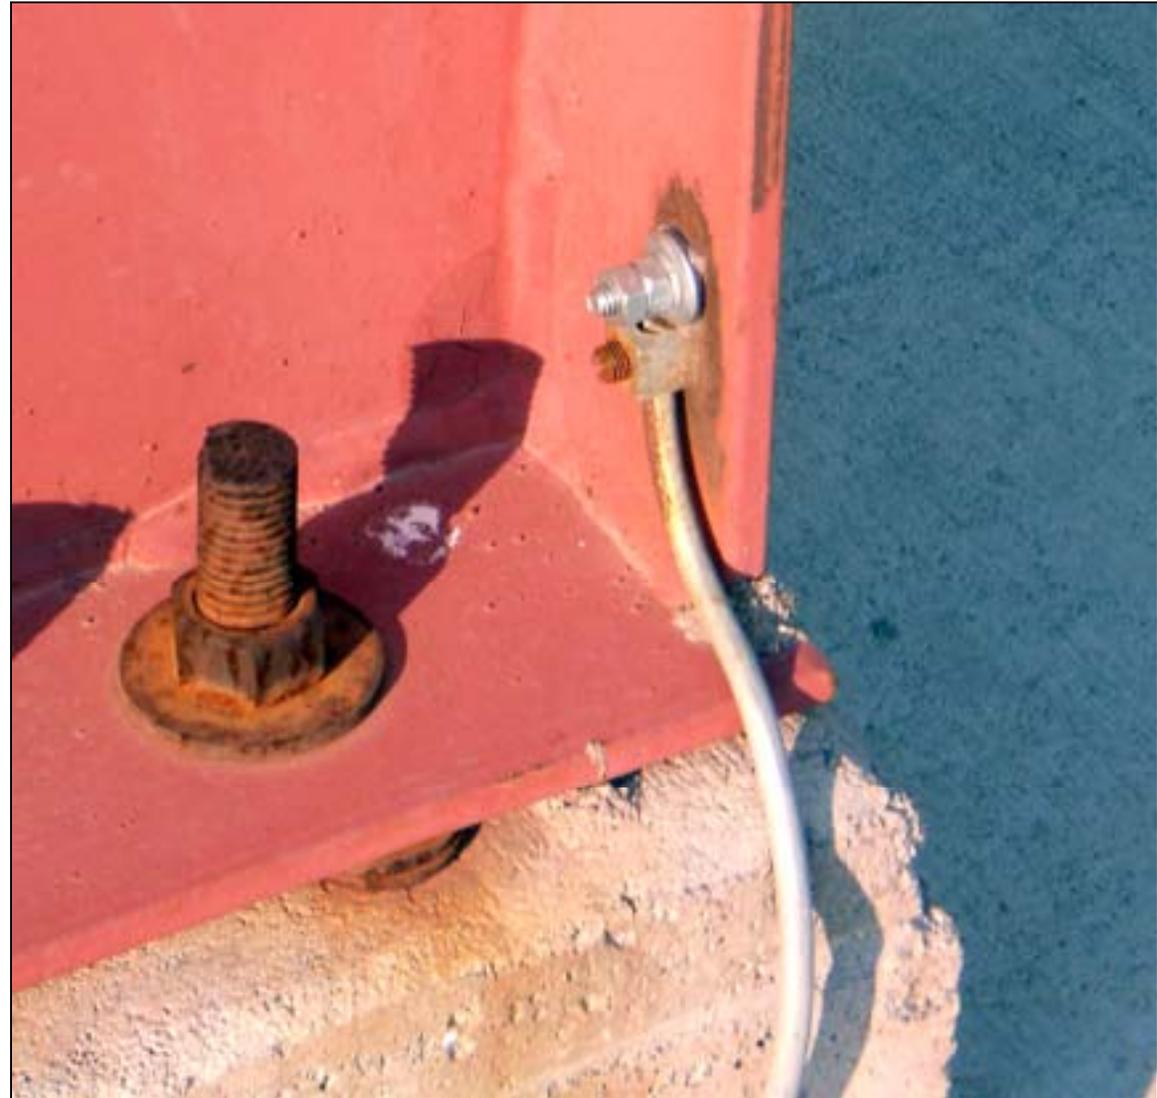
Ice bridge

**Note rust**

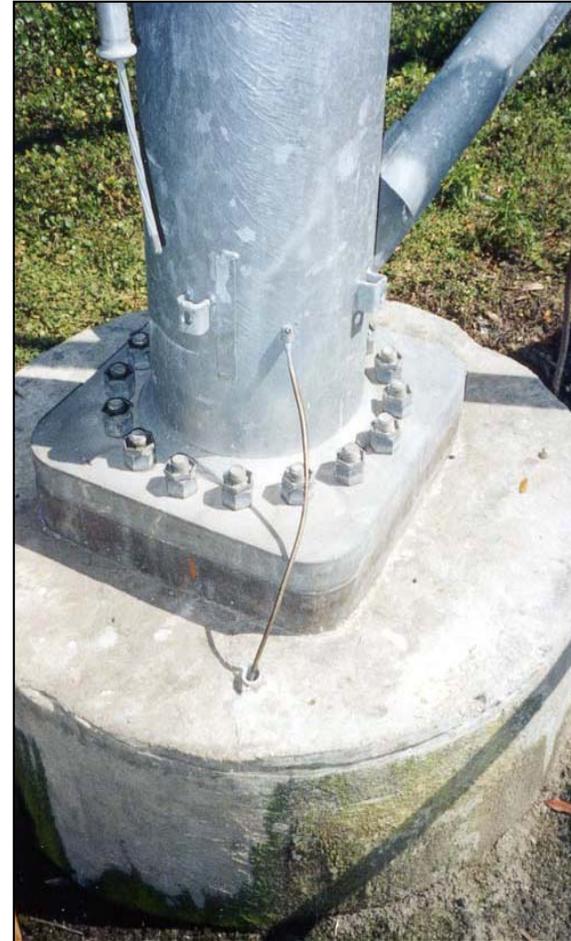
# Inadequate Tower Grounding

***Is Ufer EGC actually bonded to rebar?***

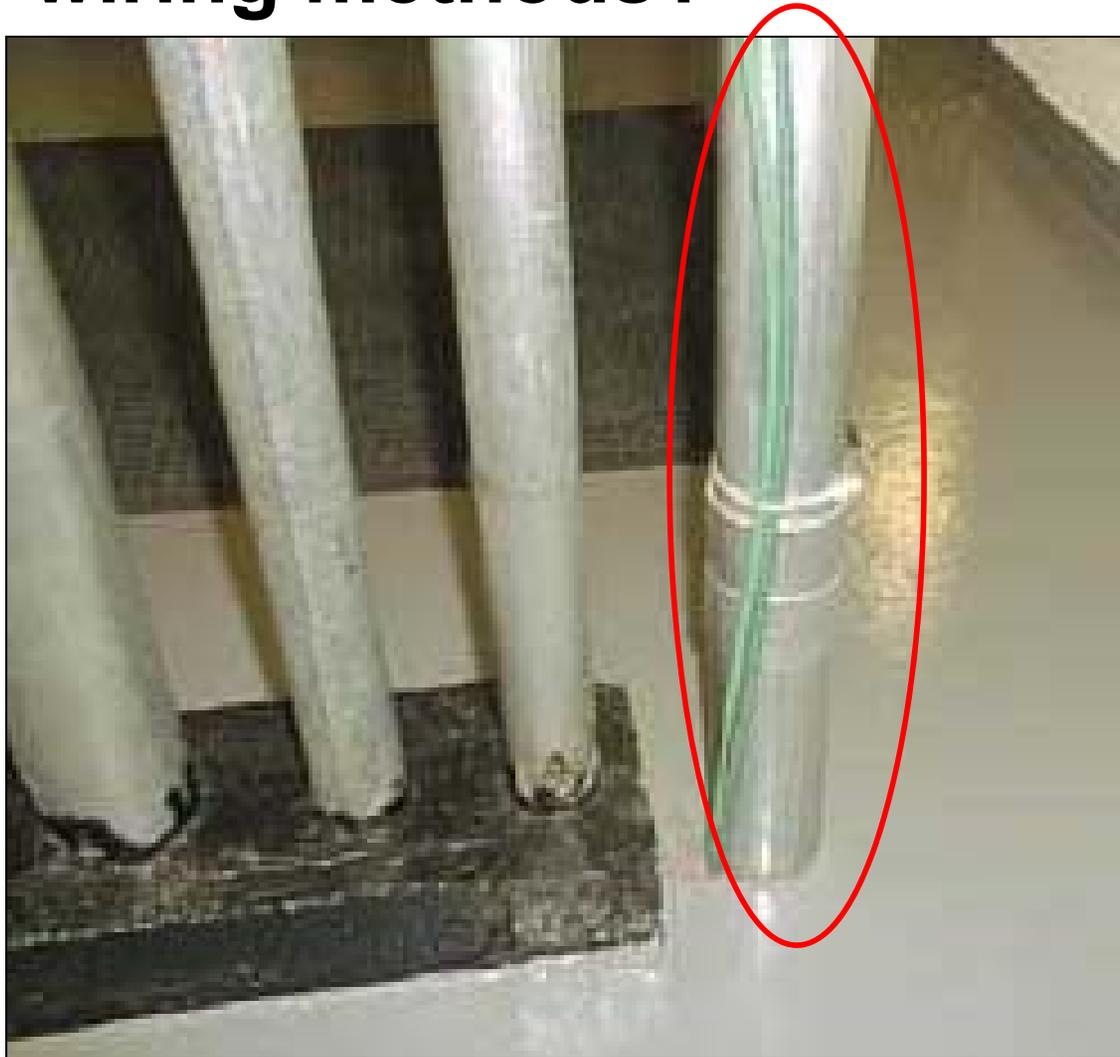
# Ground wire outside conduit

## Proper wiring methods?

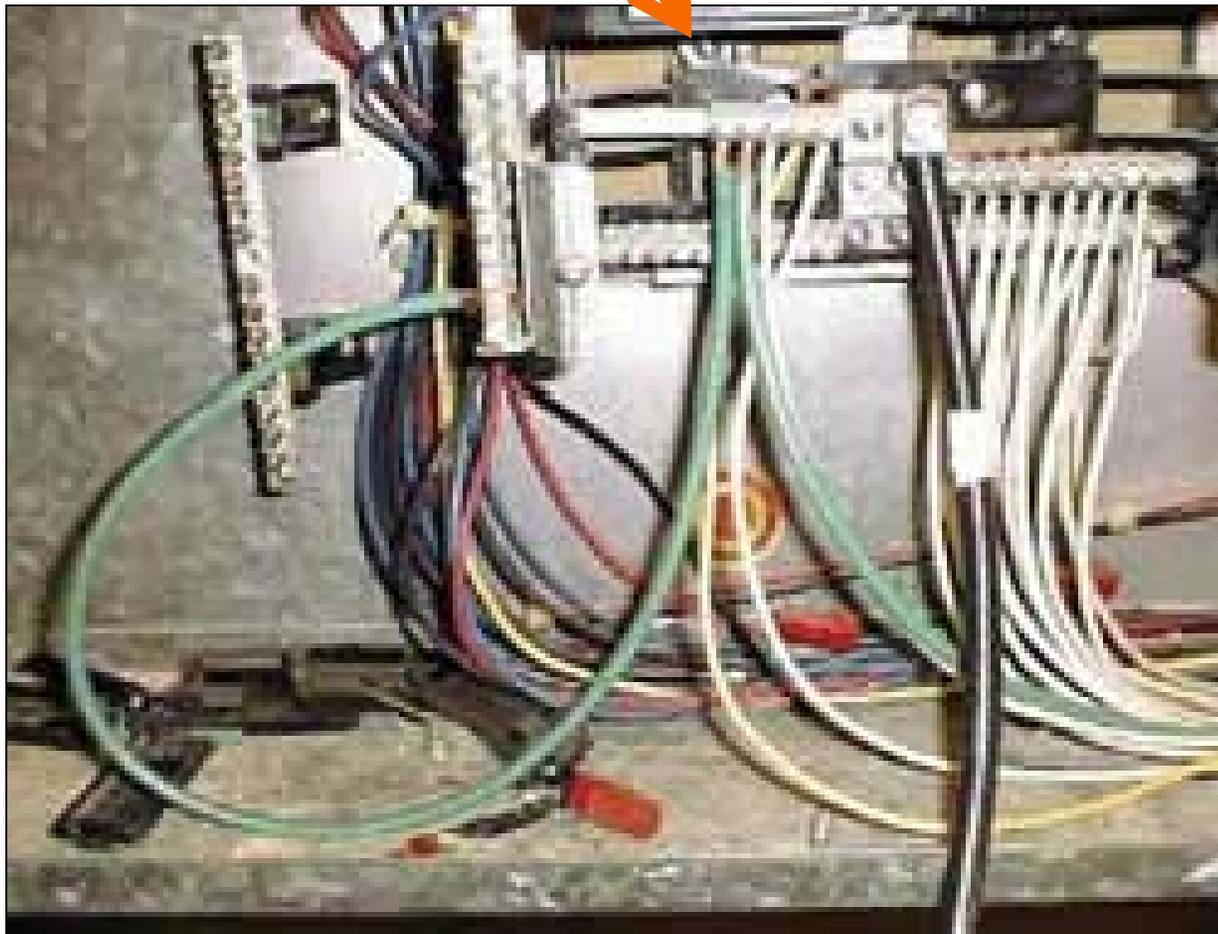
# Separate Neutral and Ground

**Improper N-G bonds**
