# Grounding and Bonding in Communications Systems

David Brender

Copper Development Association Inc.

Miramar, March 8, 2013

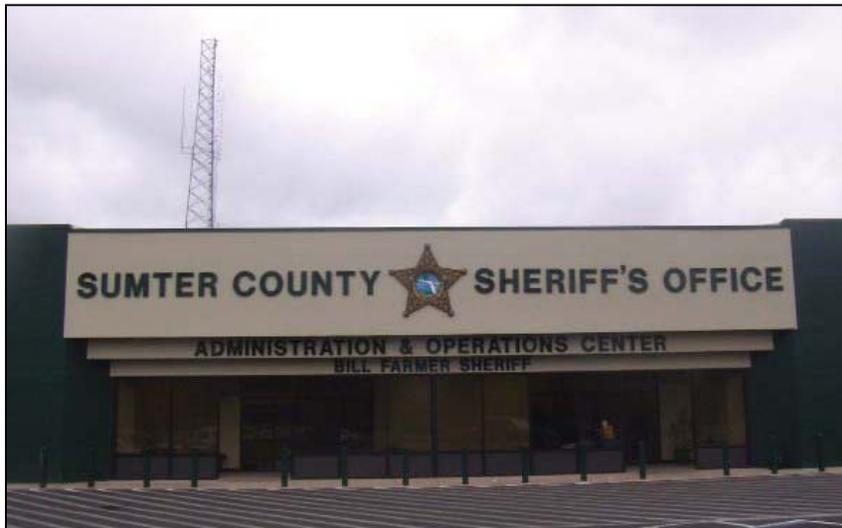
# Sumter County, FL 9-1-1

**2004 lightning strike  
took out entire facility**

Tower had separate grounding

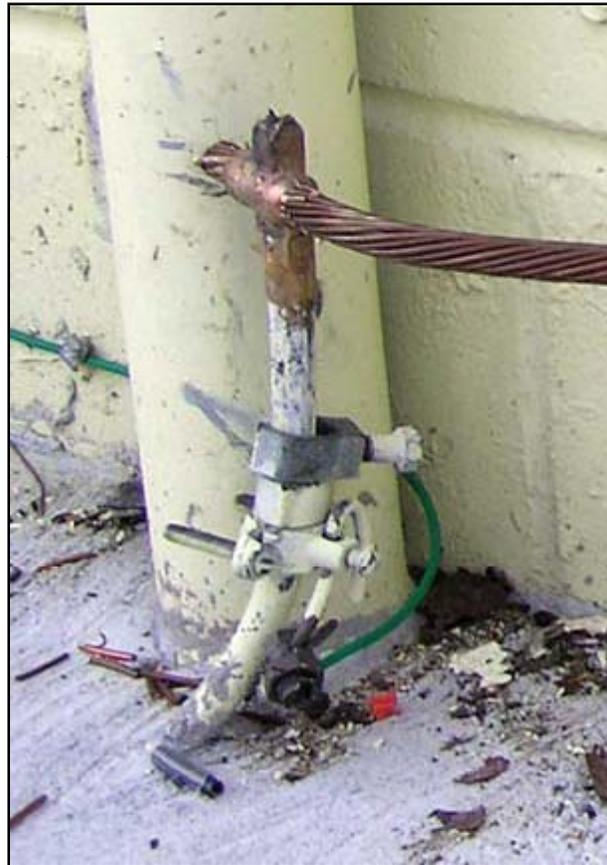
# 230 Ohms to ground

## Building had single galvanized rod

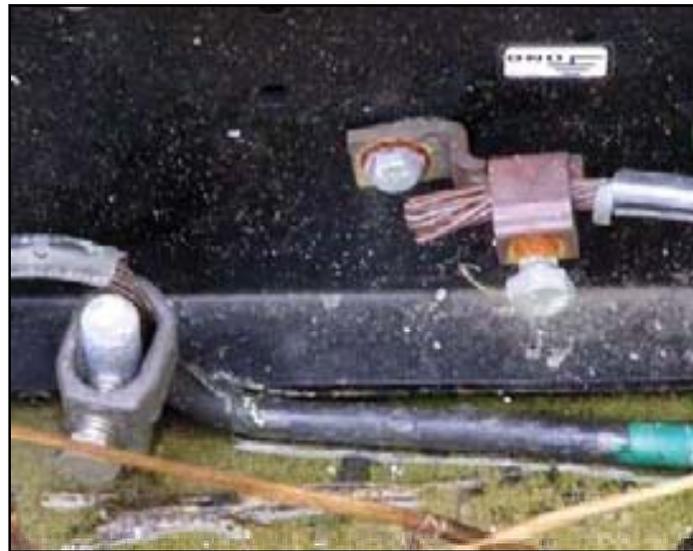
# Independent grounds

**2 emergency generators each had  
independent ground**

**Hose clamp connection**

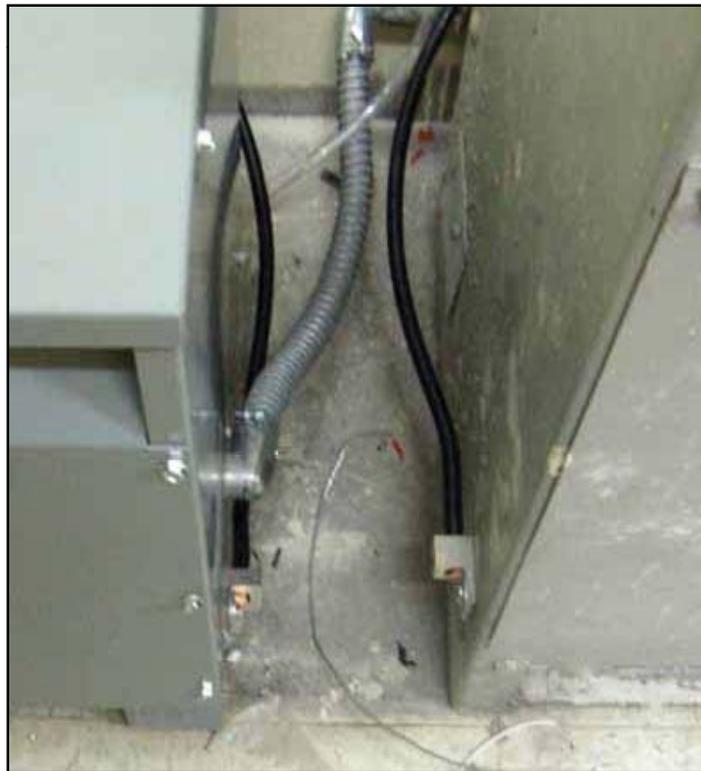
# Steel was not grounded

**2 transformers were grounded to building steel, but steel was not bonded to ground electrode**

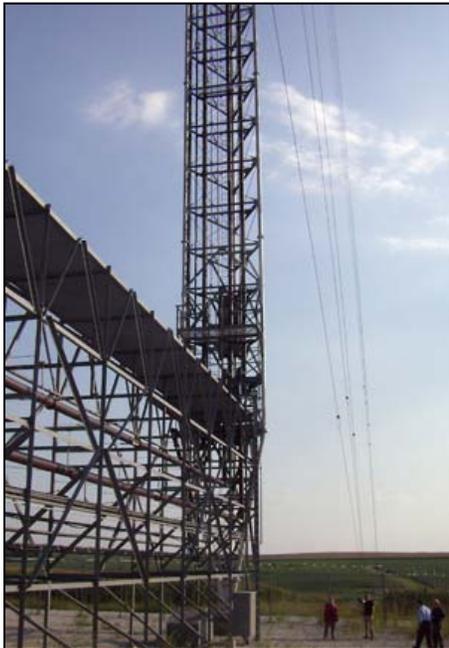
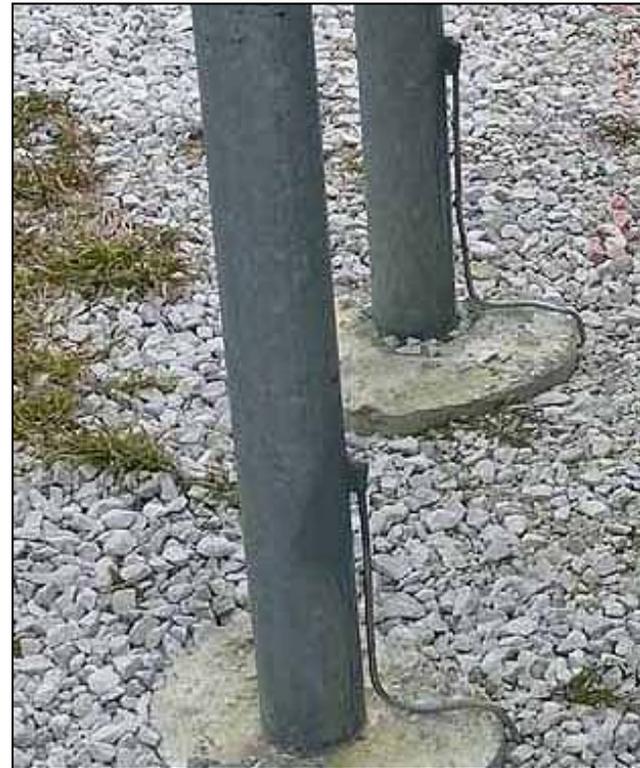
# Ice bridge

## #2 AWG connected to same rods

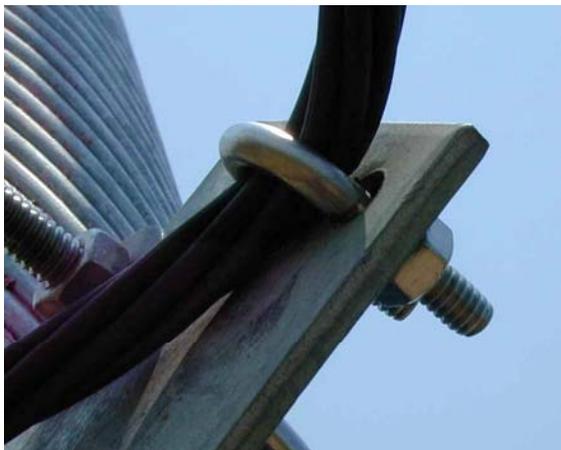
# Guy wires

**Note double U-bolts**

**Connectors not listed**

**90° angles**

**Vibration**

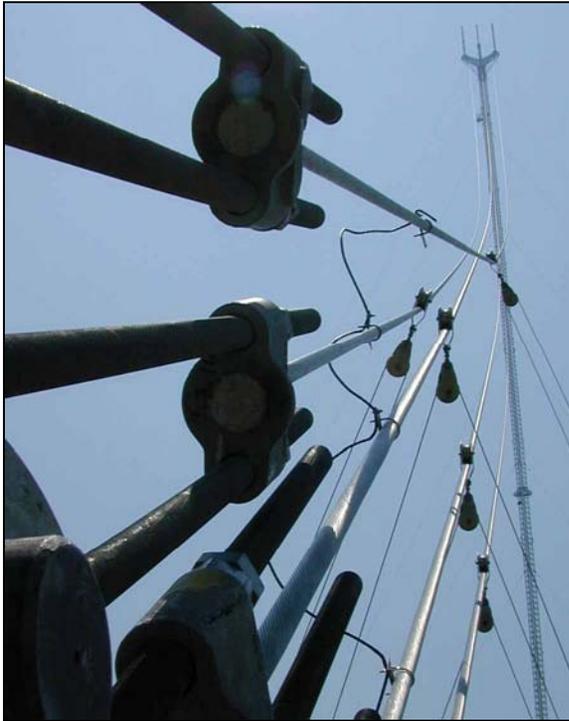
# Guy grounding

**Note right angles**

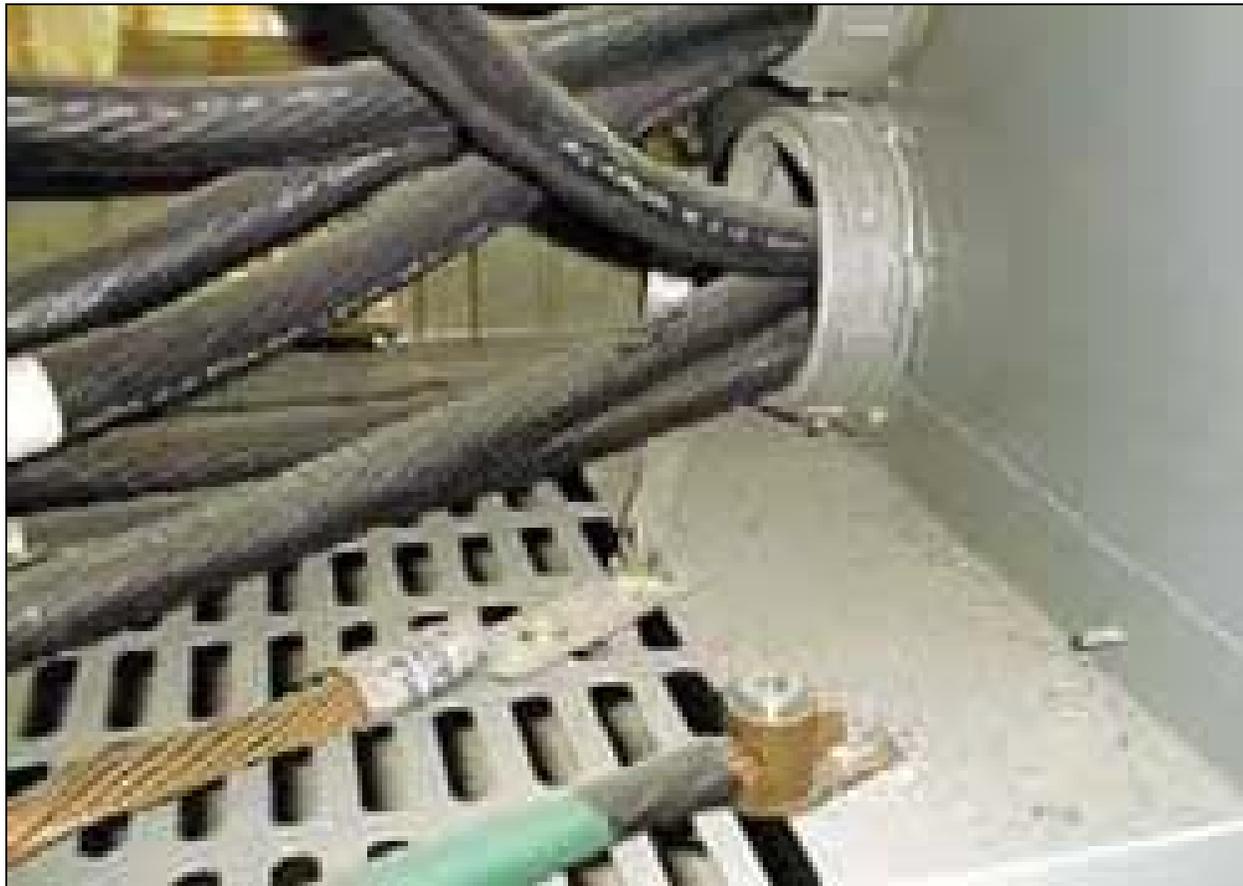
# Are connections proper?

**Look for paint or other insulation**
